Environmental Assessment Lead Visual Report

Pagoda Theatre

**1731 Powell Street
San Francisco, CA**

MHC173VC0806

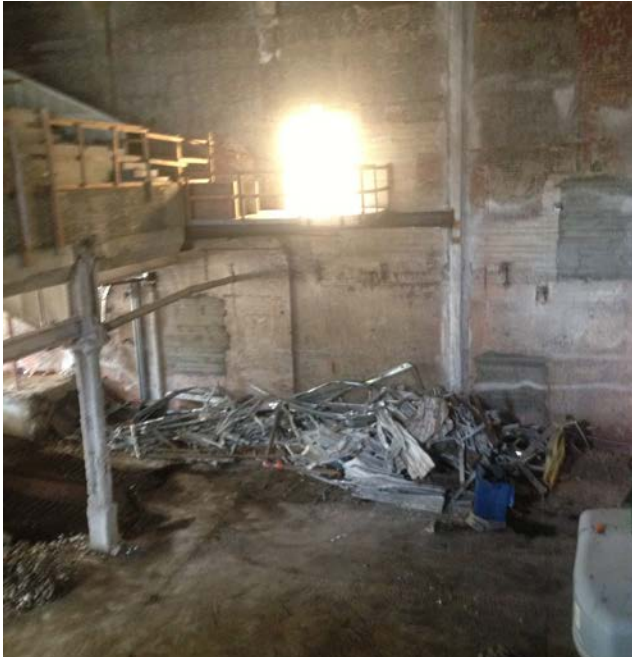
Debris pile

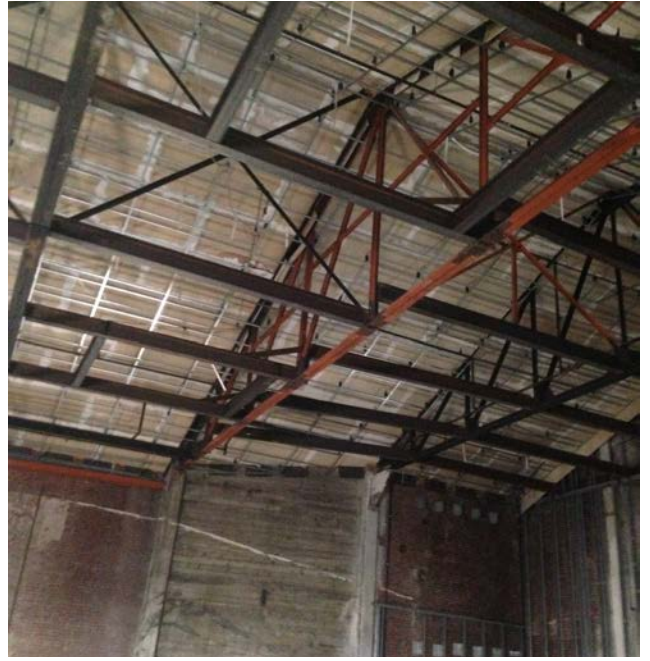
Structural Steel – Red Lead

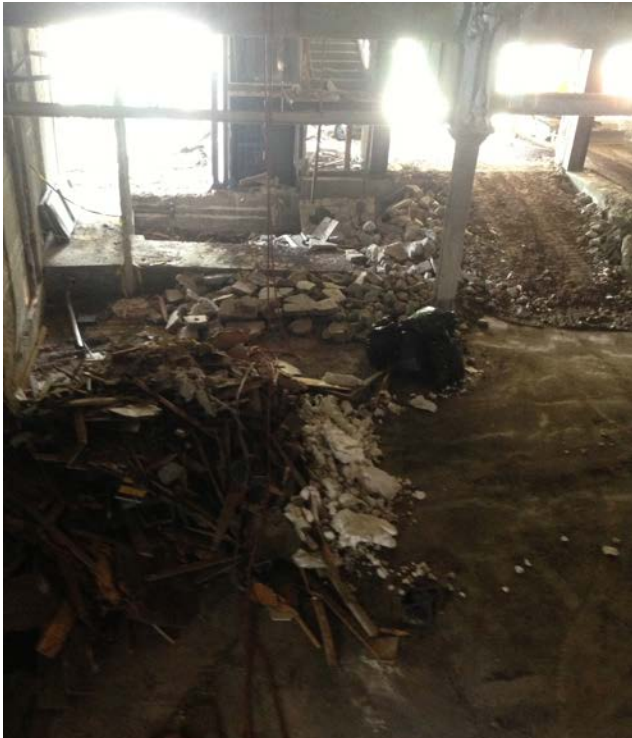
Debris pile

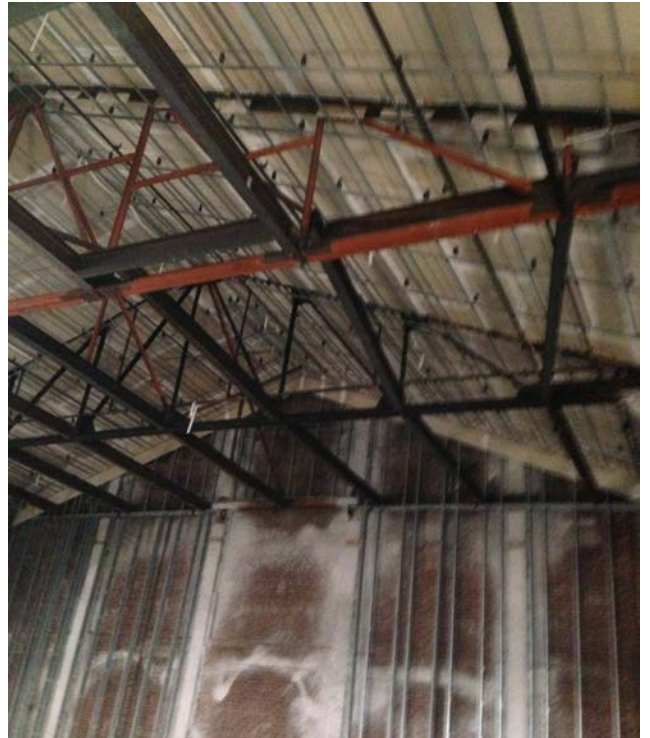
Structural Steel – Red Lead

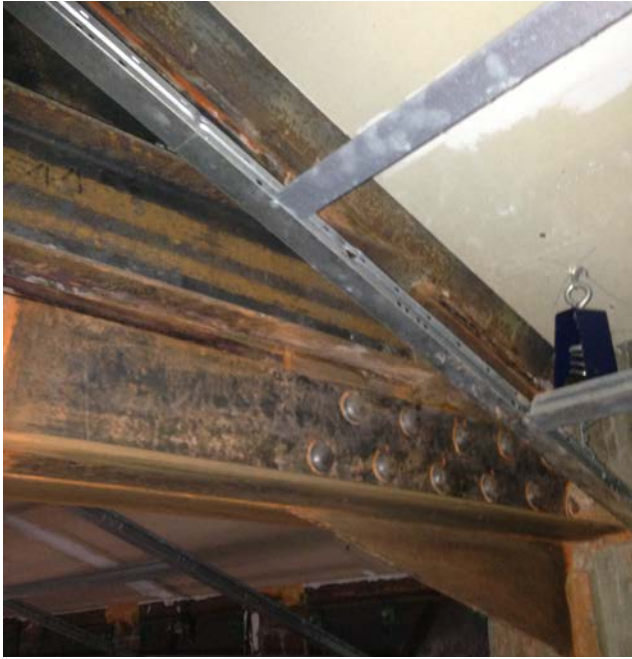
South side beam

Restoration Management Company was contracted to remove **Red Lead** from structural steel in the north and south end of the building. **The two specific locations were referred to as cut points. A visual inspection of the cut points revealed complete removal of red lead on a 3ft section of structural steel on all sides in both locations.**
